751A: NO RECEPTION ON SOME BANDS

TRADUZIONE

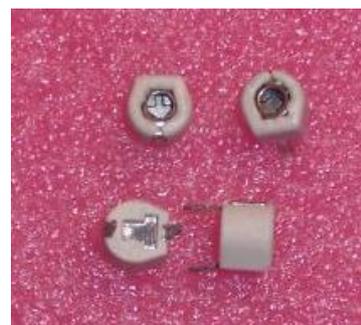
- **Murata 3-11pF** miniature trimmer capacitors, **TZ03** series
- Only 6mm dia x 5mm high excluding pins. Fits standard 2.54mm(0.1") pin grid.
- Low loss very stable ceramic dielectric.
- Rated at 100VDC.
- Utente Ebay **ecl80** (Paese: Regno Unito) iscritto fin dal 10 feb 2006 (100% feedback)

The TZ Series ceramic trimmer capacitors are built into and protected by a color coded plastic case. This unique, axle-less and solder-less construction protects the unit from damages during assembly and provides exceptionally linear temperature coefficient at low cost.

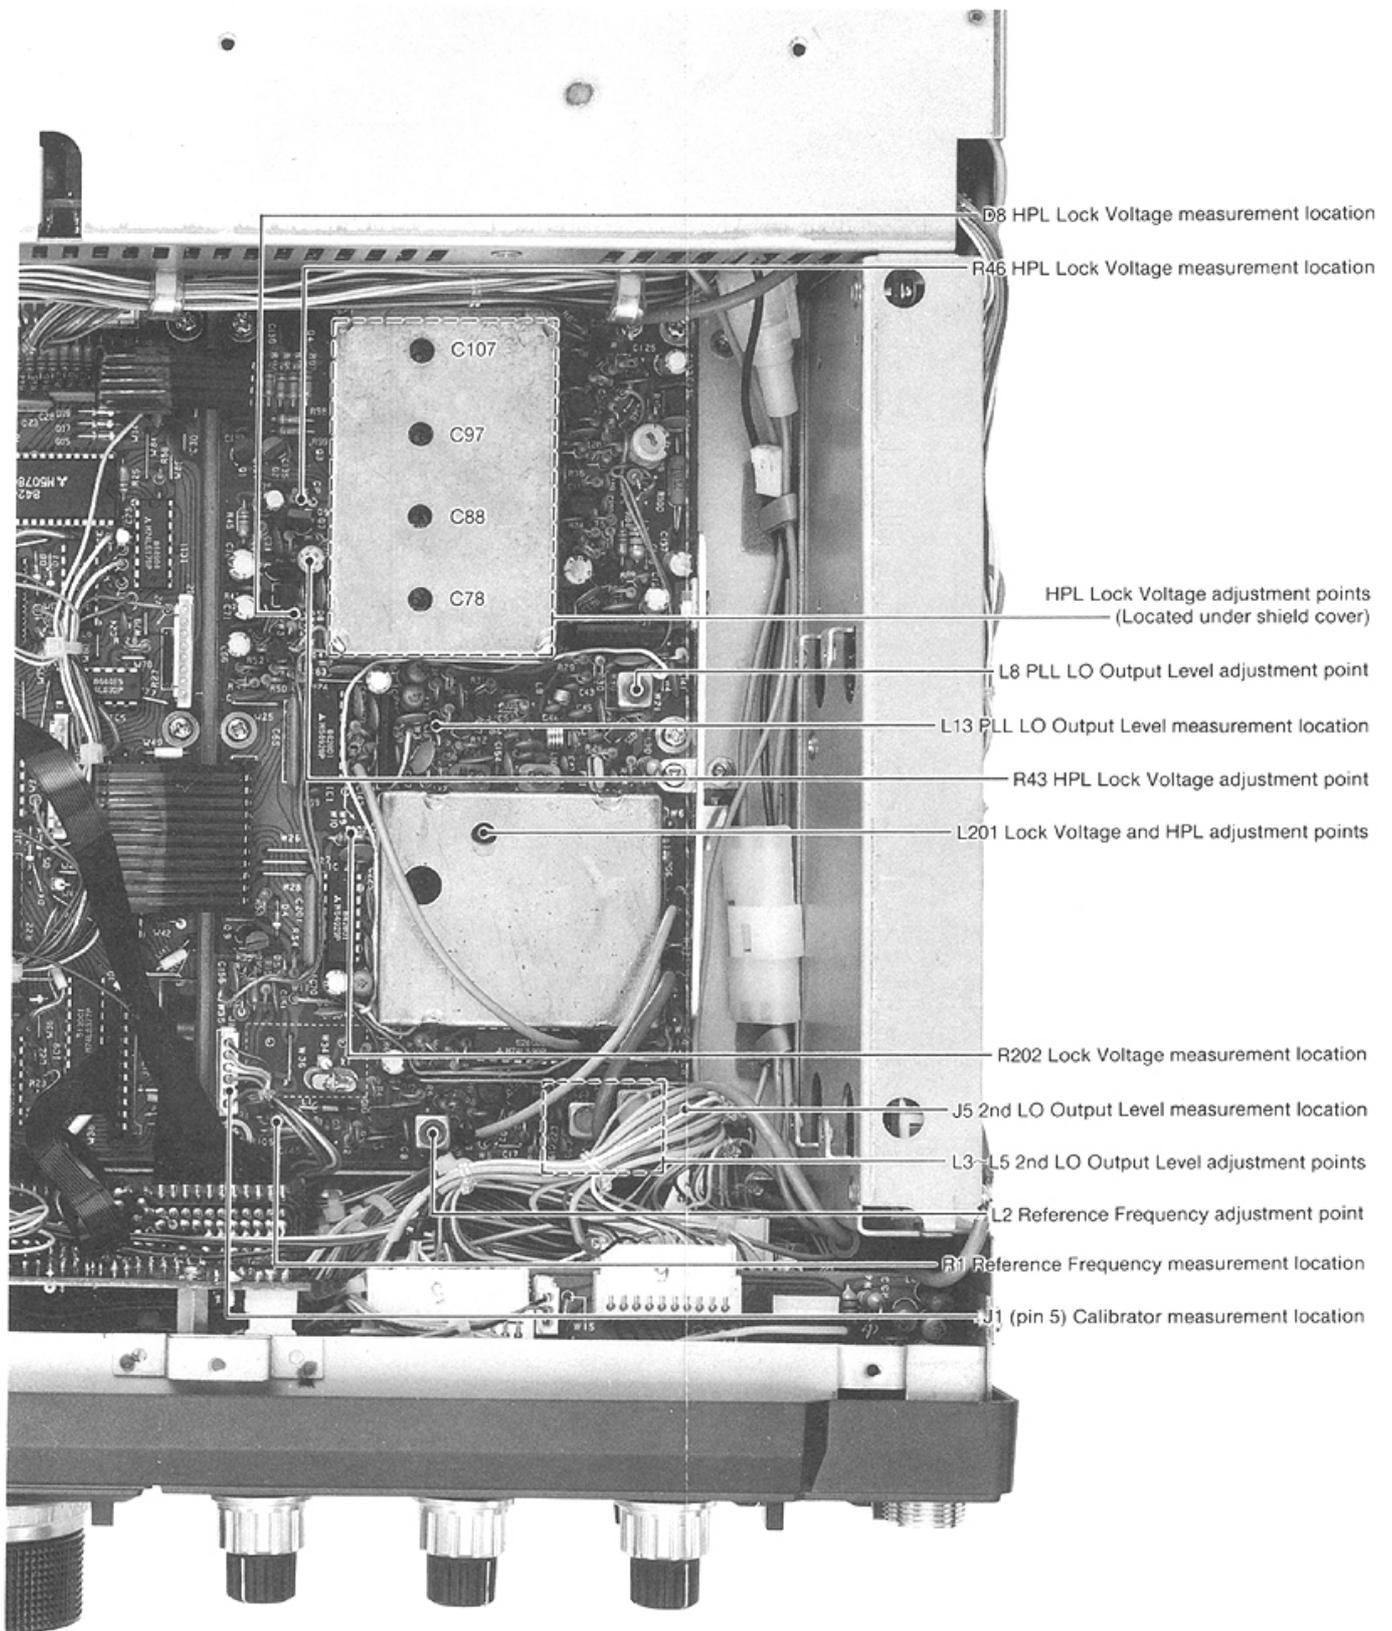
D8 HPL Lock Voltage measurement location

R46 HPL Lock Voltage measurement location

C107

C97

C88

C78

HPL Lock Voltage adjustment points
(Located under shield cover)

L8 PLL LO Output Level adjustment point

L13 PLL LO Output Level measurement location

R43 HPL Lock Voltage adjustment point

L201 Lock Voltage and HPL adjustment points

R202 Lock Voltage measurement location

J5 2nd LO Output Level measurement location

L3-L5 2nd LO Output Level adjustment points

L2 Reference Frequency adjustment point

R1 Reference Frequency measurement location

J1 (pin 5) Calibrator measurement location

Replace plastic trimmer capacitors C78, C88, C97, and C107 with ceramic types. Remove excessive wax from around replacement trimmers to prevent wax contamination. We suggest using a 12pf trimmer for C97 instead of a 7pf as listed in the service manual. This will allow you to properly adjust the HPL lock voltage for that band. Modification: If variable resistor R43 on the PLL unit is the 470 ohm type, replace it with a fixed-value 220 ohm version. If it's the 2.2k type, replace it with a fixed-value 1.2k resistor.

The variable resistor R43, 470ohm, should be exchanged to a fixed resistor of 220 ohm.

6 - 2 PLL ADJUSTMENT

2			1.5~2V			Verify
HPL LOCK VOLTAGE	1	PLL	Connect an oscilloscope to R46.	6.5V	PLL	C78	
	2			C88			
	3			C97			
	4			C107			
	5			L201			
	6			R43			
	7						
	8			2.5V		Connect an oscilloscope to the cathode of D8.	
2nd LO OUTPUT LEVEL	1	PLL	Terminate J5 to ground with a 50Ω resistor. Connect an RF Voltmeter to J5.	Adjust to maximum output: 250~400mV rms	PLL	L3~L5	
NOTE: After completing the adjustment, return J5 to its original condition.

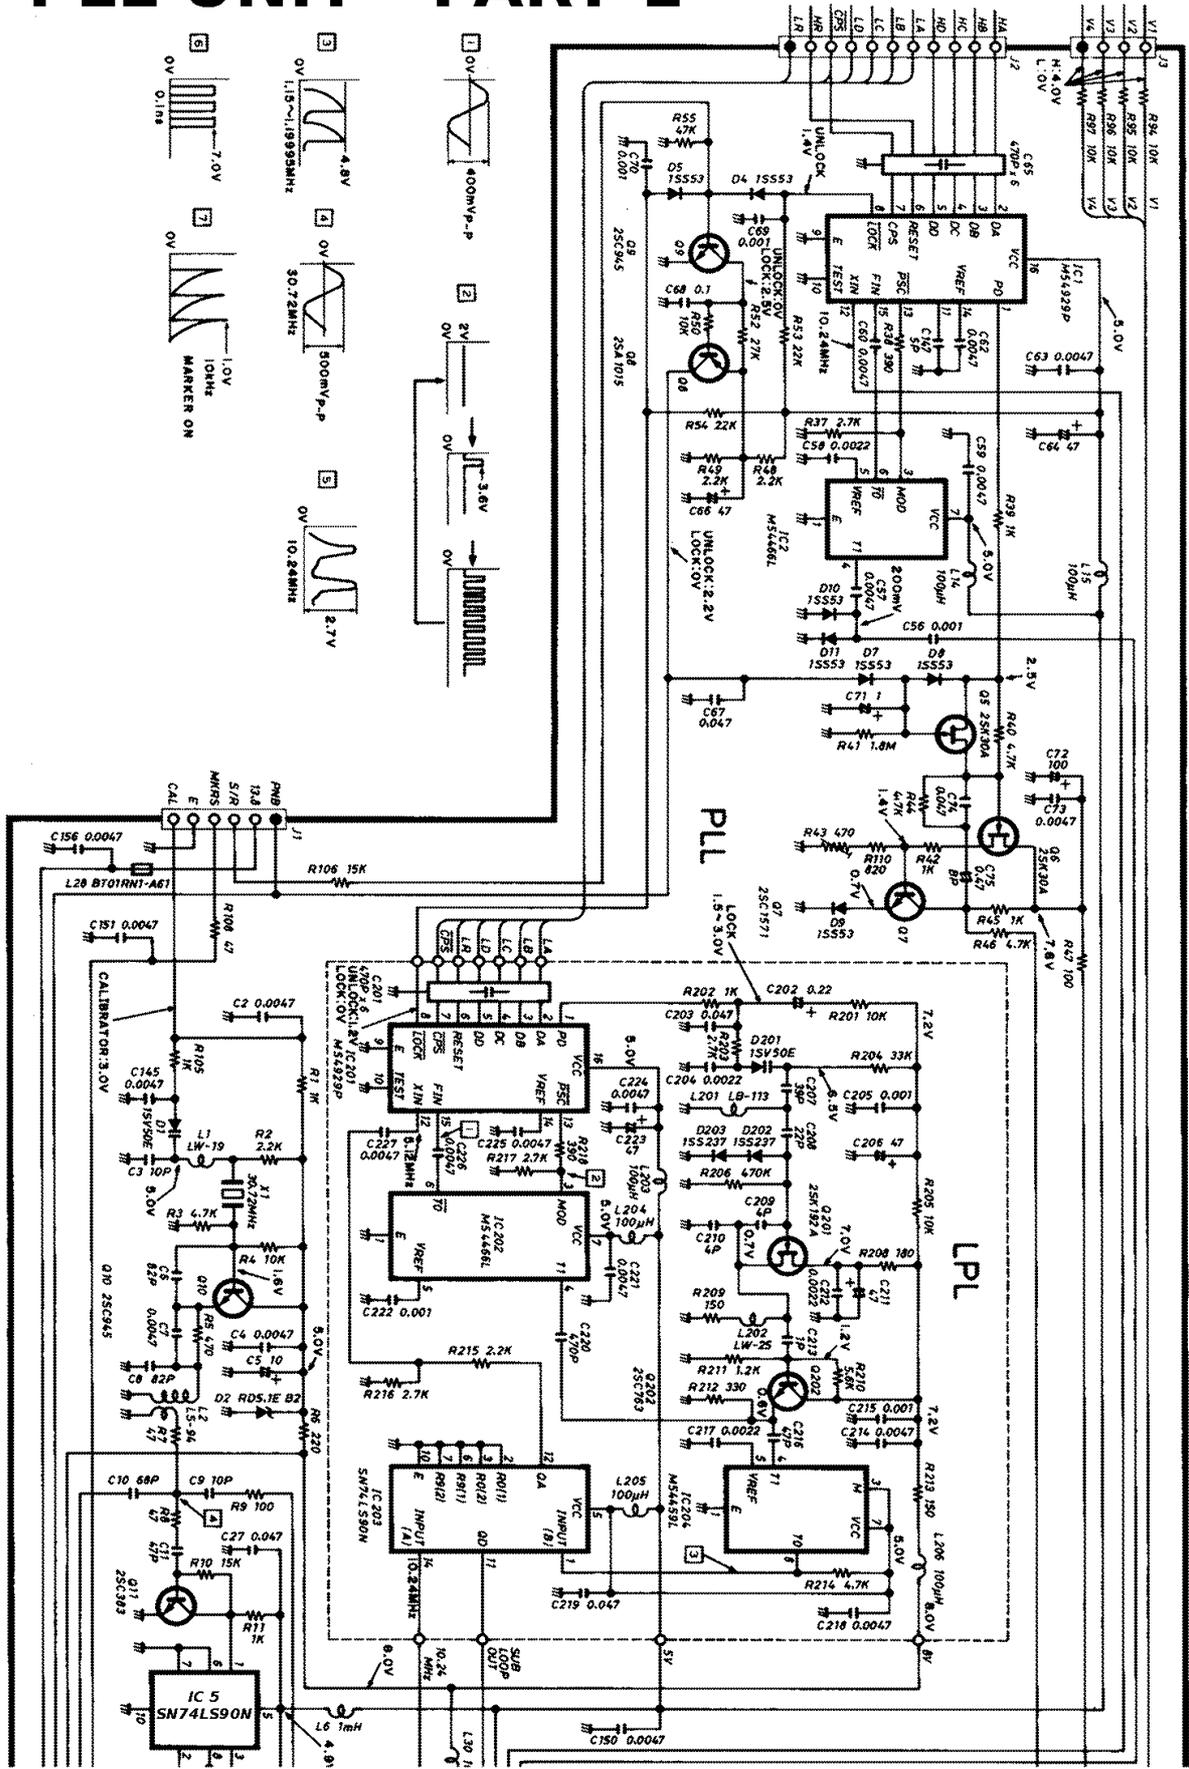
PLL UNIT - PART 1

For verifying frequency, connect to PIN 1 of IC5 (SN74LS90N)

Nota: Il controllo della frequenza di 30,720 Mhz deve essere verificato dal PIN 1 dell'IC 5, come indicato nello schema del PLL indicato nella pagina seguente.

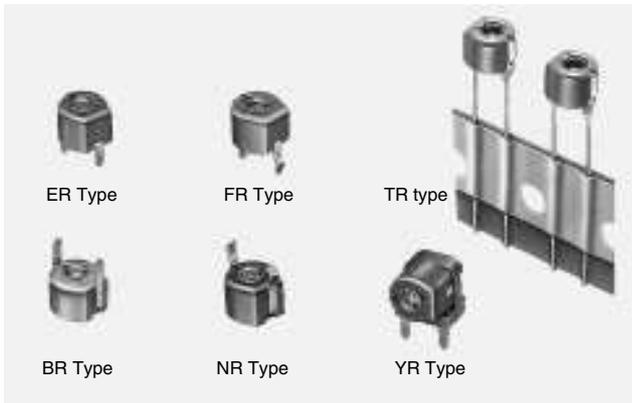
TZ03 Series

- Excellent shock and vibration resistance
- Exceptionally linear TC
- Dust and flux resistant construction
- Plastic case meets UL94V-0
- Available on tape and reel for automatic insertion

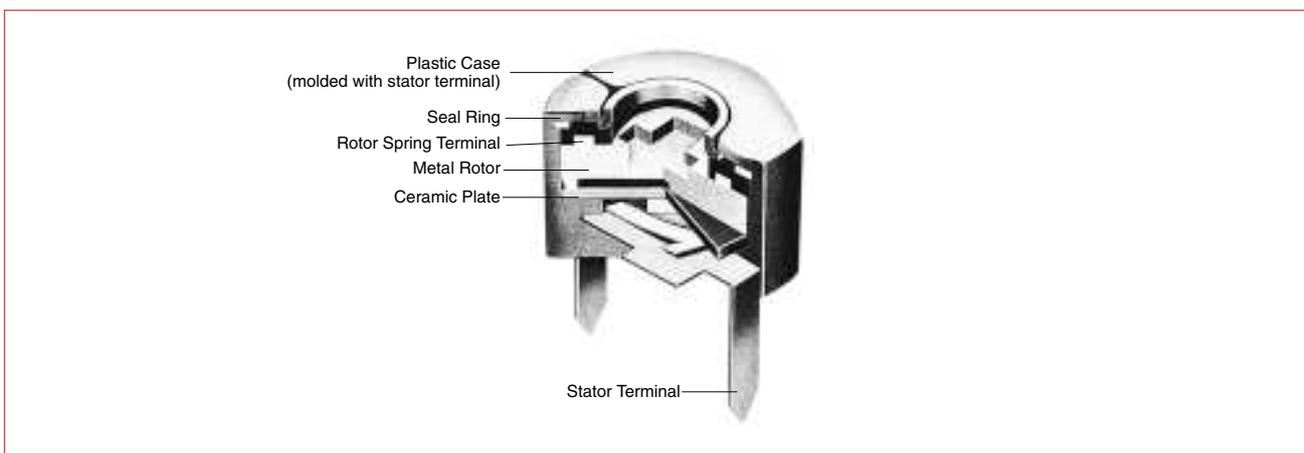
Working Voltage: 100VDC or 50VDC

Withstanding Voltage: 220VDC (100V units) or 110VDC (50V units)

Insulation Resistance: 10⁴MΩ min. (50VDC, C max.)

Driving Torque: 1.96 to 14.7mNm (20 to 150)
